Manhole Inspection Summary

Manhole # S33M__041MH

Insp Date: **3/6/08 8:50 AM**

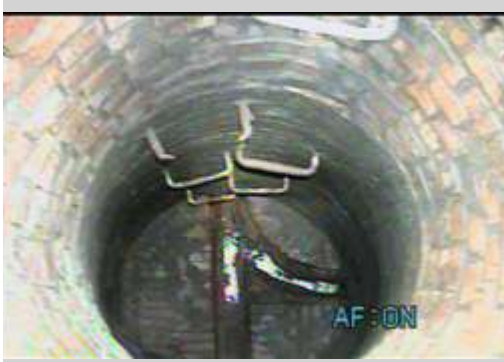
Defect 1

Count: **5**

Missing: **1**

☒ **Corroded**

missing/corroded steps

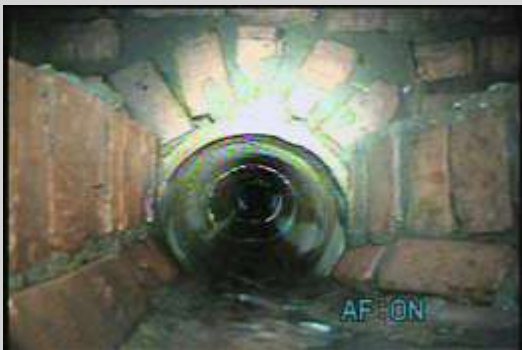
12 O'Clock Outflow

8 in. Circular Gravity Sewer
Pipe Out @ 12 O'Clock

Pipe Material: **Clay** ☐ Pipe Lined

Invert Depth: **10.90** (ft.) Flow Characteristics: **Slow**

Deposits: ☒ None ☐ Mud ☐ Sludge ☐ Debris ☐ Grease

Infiltration: **None** Pipe Seal Cond: **Unknown**

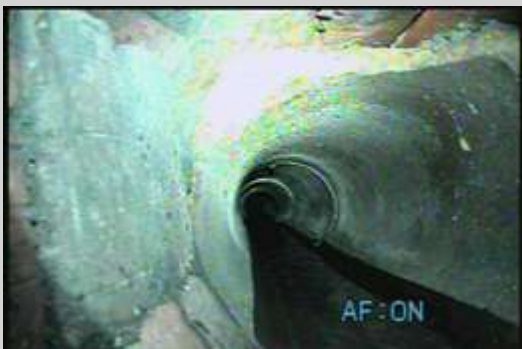
3 O'Clock Inflow

8 in. Circular Gravity Sewer
Pipe In @ 3 O'Clock

Pipe Material: **Clay** ☐ Pipe Lined

Invert Depth: **10.50** (ft.) Flow Characteristics: **Slow**

Deposits: ☒ None ☐ Mud ☐ Sludge ☐ Debris ☐ Grease

Infiltration: **None** Pipe Seal Cond: **Unknown**

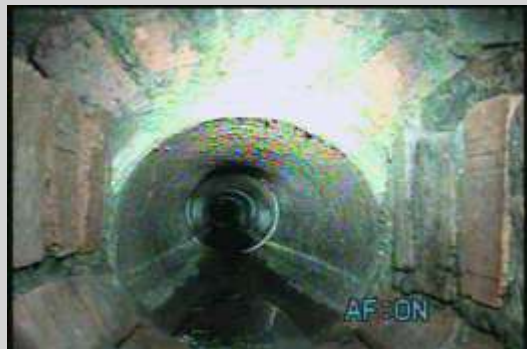
6 O'Clock Inflow

8 in. Circular Gravity Sewer
Pipe In @ 6 O'Clock

Pipe Material: **Clay** ☐ Pipe Lined

Invert Depth: **10.70** (ft.) Flow Characteristics: **Slow**

Deposits: ☒ None ☐ Mud ☐ Sludge ☐ Debris ☐ Grease

Infiltration: **None** Pipe Seal Cond: **Unknown**
